CHERNOBYL ACCIDENT

© M. Ragheb
12/4/2021

INTRODUCTION

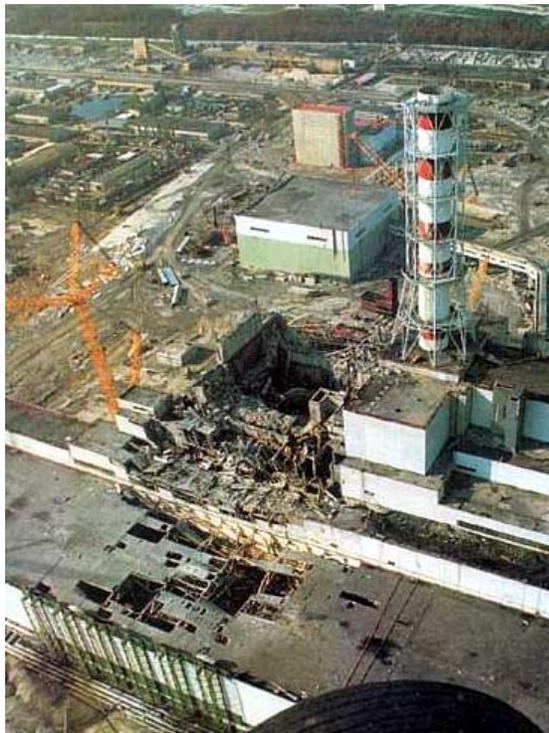
Figure 1. Damaged unit 4 of the Chernobyl plant, before being enclosed in a concrete silo.

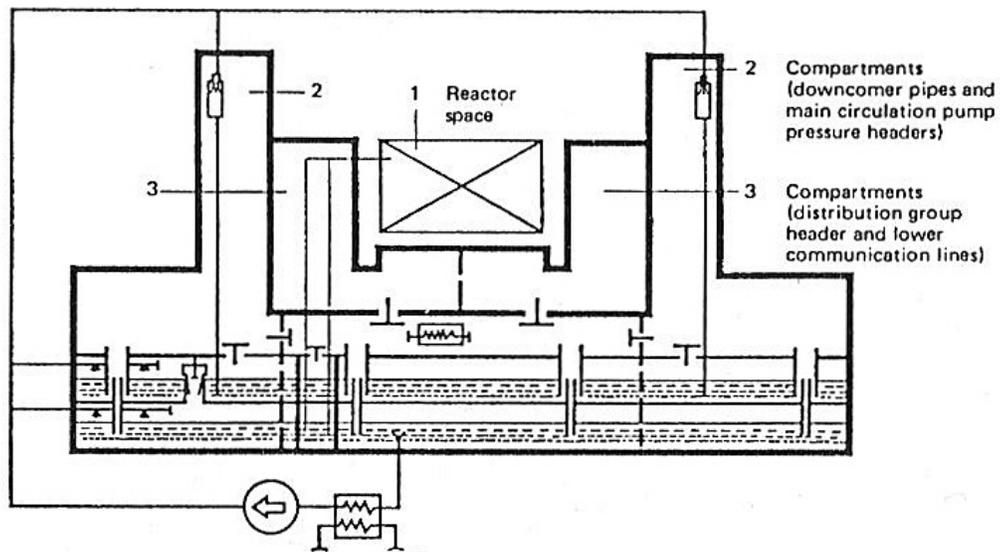
Figure 6. Schematic diagram of the containment system designated as the “accident isolation system.” A design flaw involves the placing of the pressure suppression pool under the reactor core creating the possibility of a steam explosion from the possible interaction of molten corium material with the water. Source: IAEA.

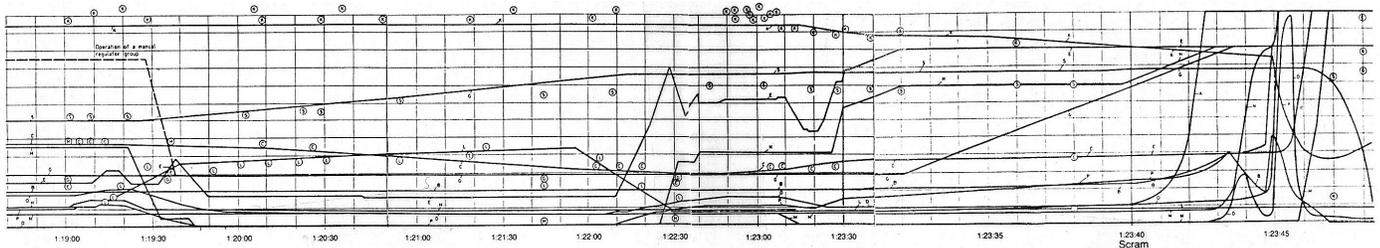
Figure 10. Accident sequence of the Chernobyl unit 4 accident. Vertical lines represent 10 second intervals from 1:19:00 to 1:23:30. At that point vertical lines represent 1 second intervals. At 1:23:43, the neutron power curve switches from A to D, with a change in the vertical scale.

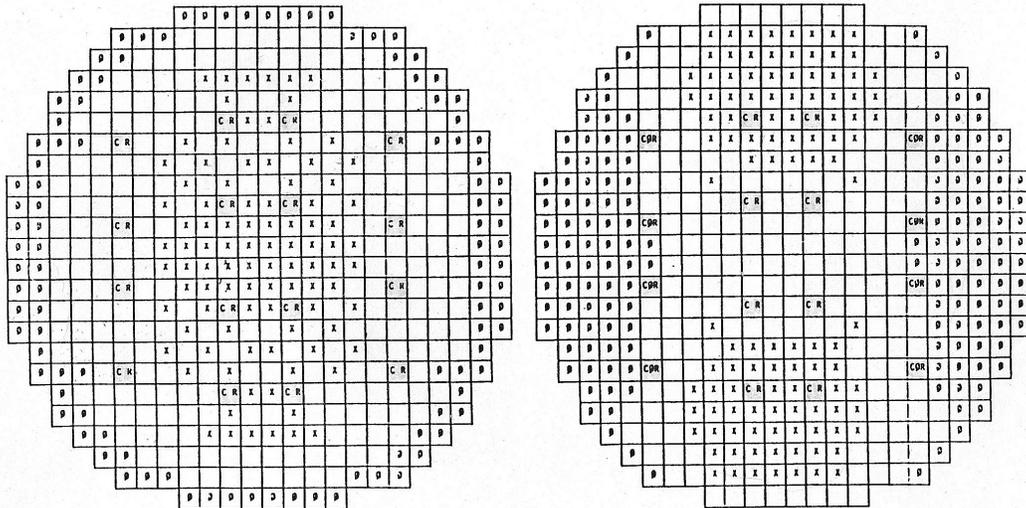
Figure 11. Initial radial power distribution (left) and radial power distribution at the time of the power excursion (right). CR: control rods, x: $P > 1.3 P_{\text{average}}$, ϕ : $P < 0.7 P_{\text{average}}$. At the time of the accident, the core had split into two cores.

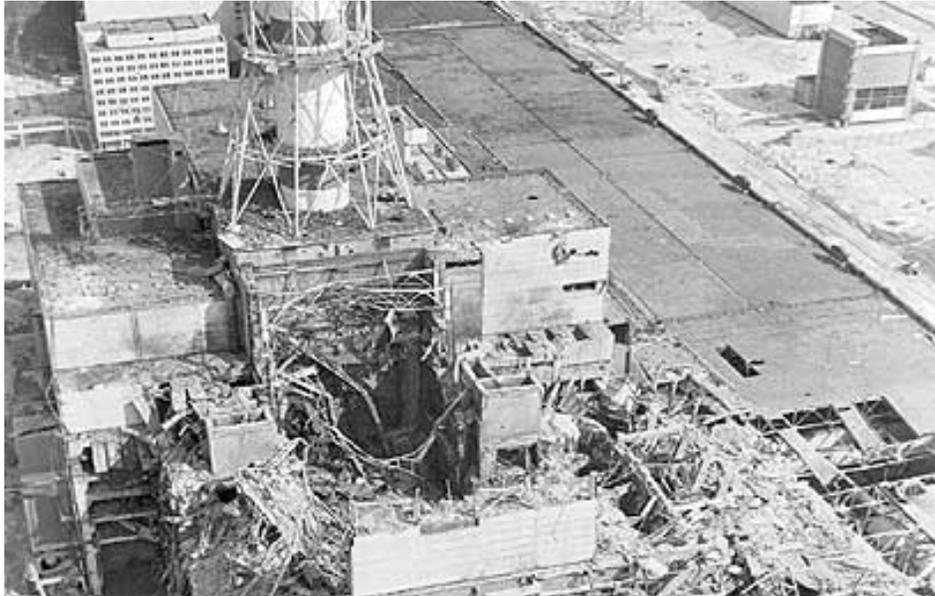
Figure 12. Aerial picture into the Chernobyl damaged unit 4 reactor core.

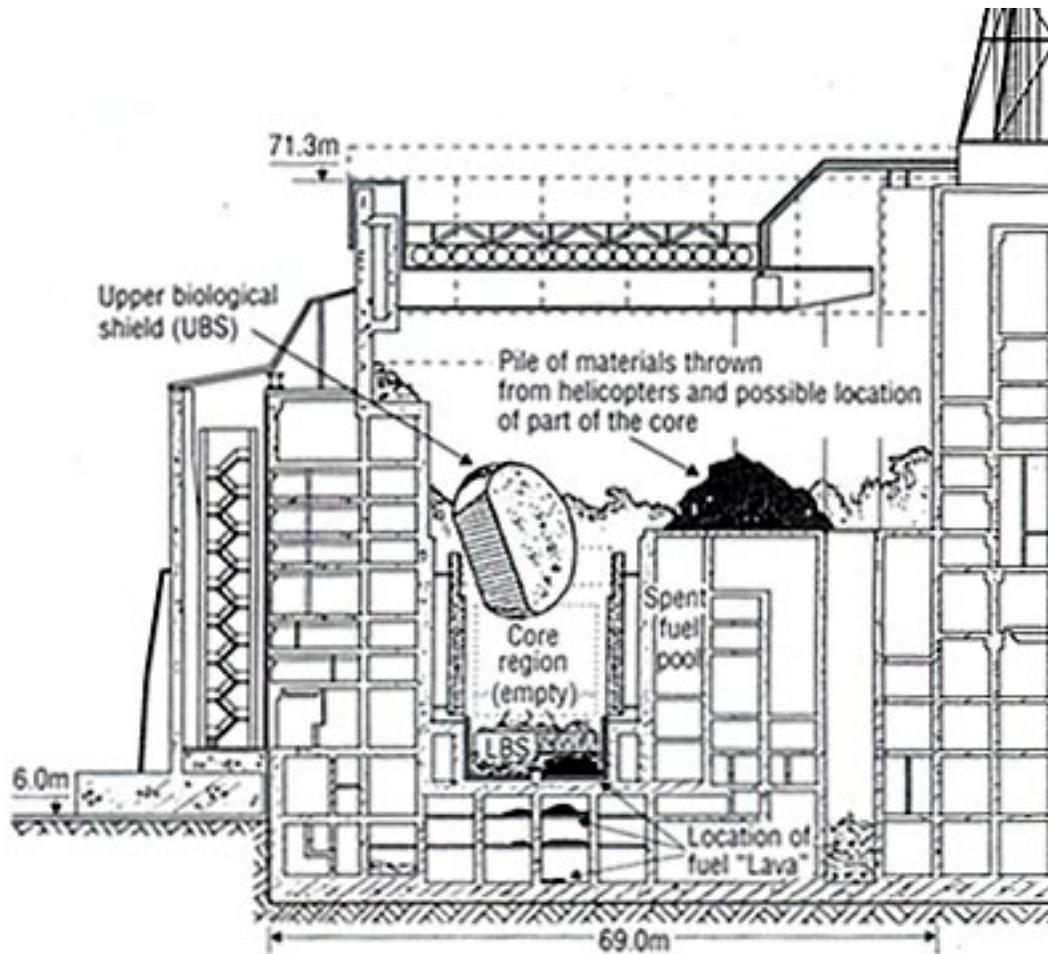
Figure 13. Concrete silo constructed around the Chernobyl unit 4 damaged core.

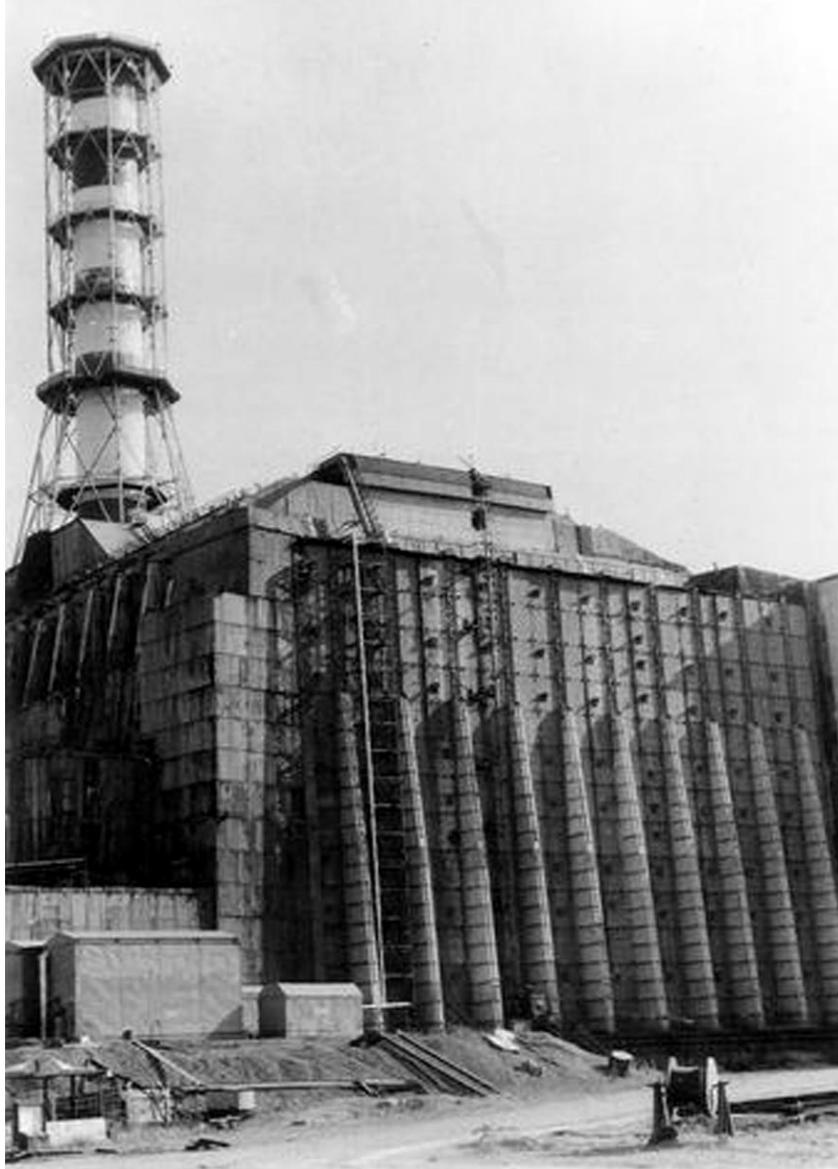
Figure 14. Chernobyl unit 4 enclosed in concrete silo.

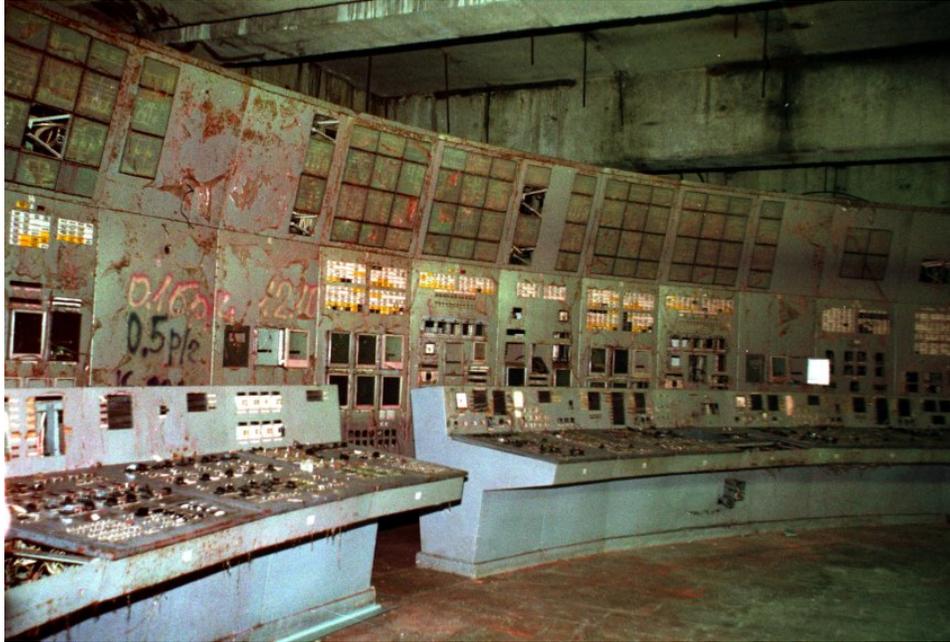
Figure 16. Remnant of Control room of Chernobyl unit 4.

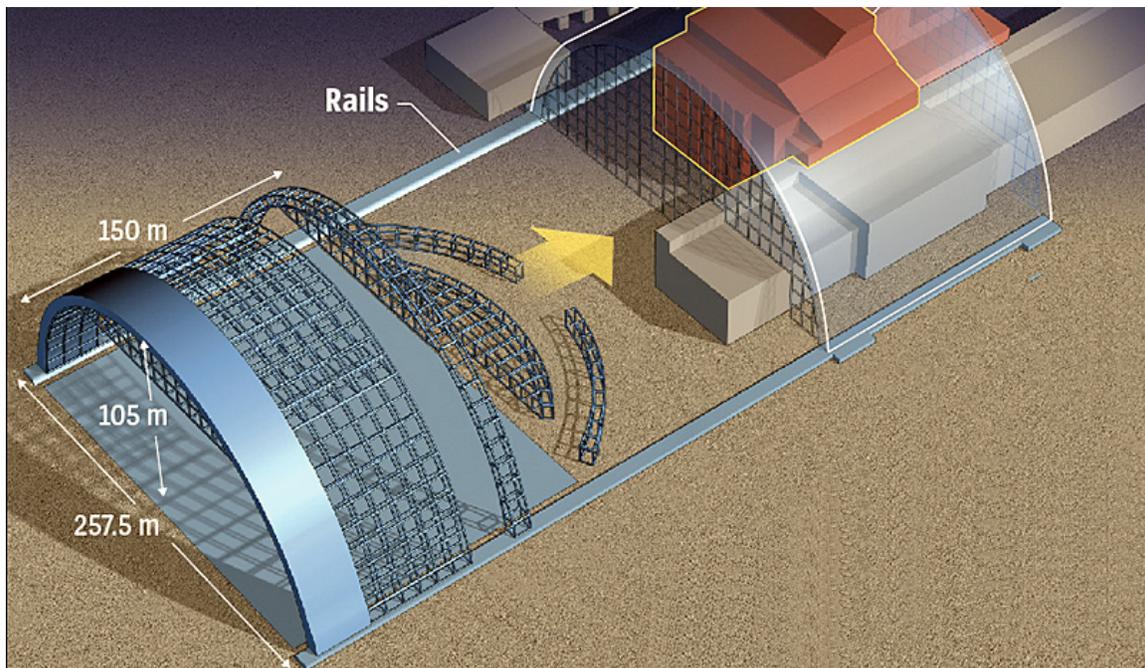
Figure 20. Metallic vault for the damaged Chernobyl unit 4 reactor. The metallic shield was constructed near the reactor then moved on rails to cover it. Source: Der Spiegel.

The concrete silo encasing the burned reactor at Chernobyl is crumbling, threatening to leak radiation through the effects of wind, rain and snow.
