STEAM GENERATOR LEAKAGE AT THE BN-350 DESALINATION PLANT

© M. Ragheb
12/13/2010

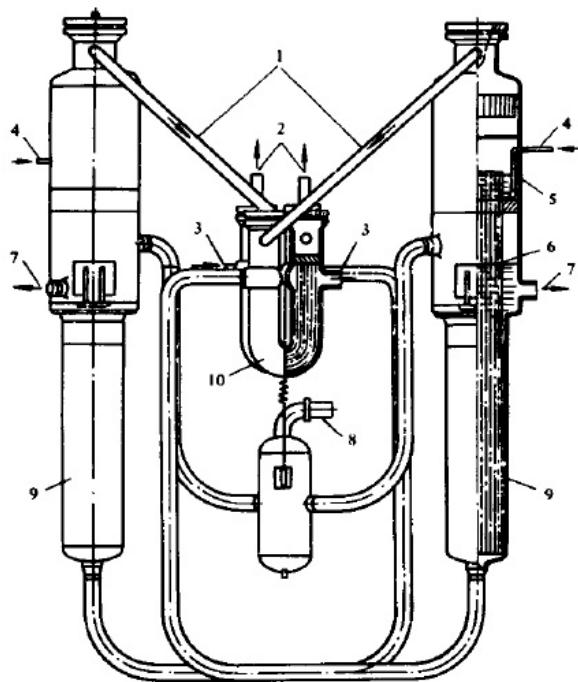
Figure 7. BN-350 steam generator. 1: saturated steam inlets, 2: Superheated steam, 3: Sodium inlet, 4: Feedwater inlet, 5: Water level, 6: Sodium level, 7: Sodium outlet, 8: Burst diaphragm, 9: Evaporator, 10: Superheater.

Through 1974, two major leaks and three smaller leaks occurred at the BN-350 plant. They were initiated from the end cap welds and caused by micro cracks in the end cap weld seam zone. They were attributed to mechanical deformations introduced during the end cap manufacture process.

After 7 days of operation, one of the evaporators in the recently re-tubed loop number 5 failed leading to a significant leak. In that event 120 tubes failed with 800 kg of water leaking, possibly interacting with the sodium causing a fire.

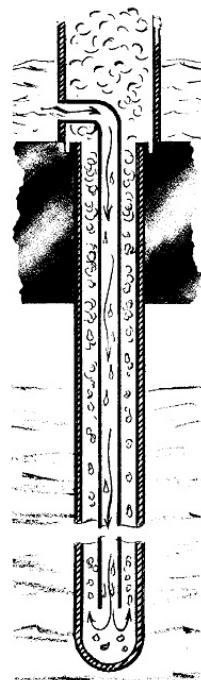
Each evaporator contained 816 bayonet tubes that were 3.3 cm in outer diameter and 3 mm in thickness with a welded end cap and a 1.6 cm x 1.4 mm internal downcomer tube. These were a modification of an earlier design that was 3.2 cm x 2 mm in dimensions.

During the startup tests, leaks were detected at the tube sheets welds and the end cap welds. In operation, eight evaporator leaks occurred through 1975 involving all but loop 4 of the loops.

Figure 8: BN-350 bayonet steam generator.
