SODIUM-GRAPHITE REACTOR EXPERIMENT, SRE INCIDENT

© M. Ragheb
11/19/2018

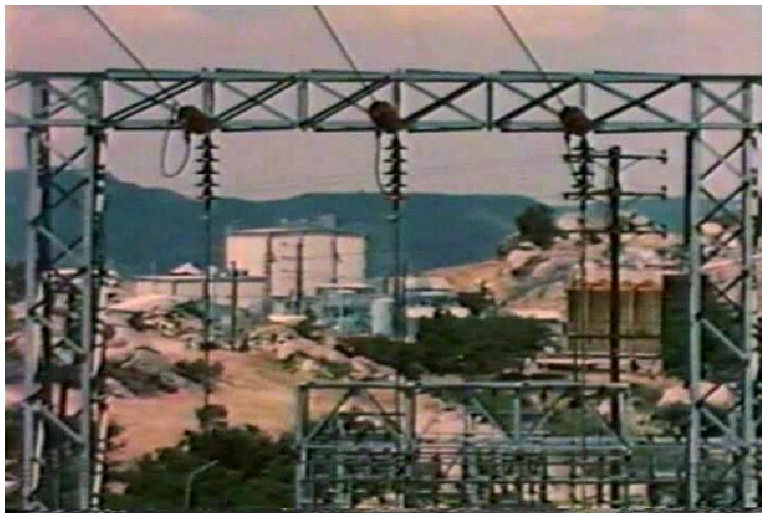
Figure 1. The Sodium Reactor Experiment, SRE, was a Na-cooled, graphite moderated thermal neutron spectrum reactor experiment producing 5.8 MWe of electrical power.

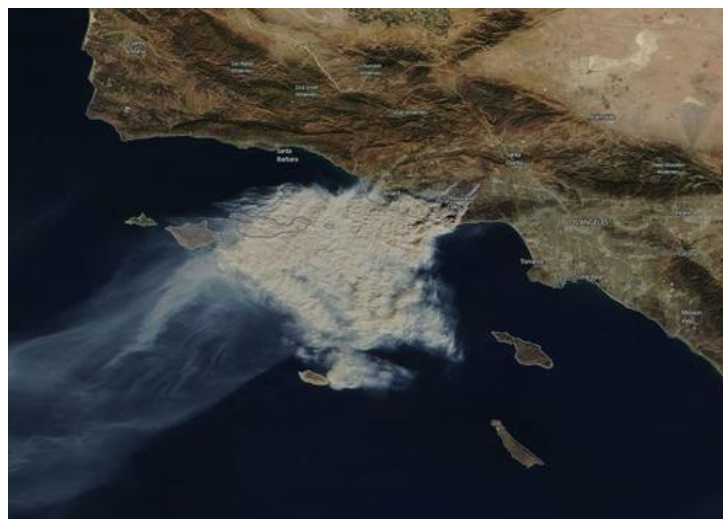
Figure 23. GOES-16 Weather satellite view of the Woolsey fire, November 2018.
Source: NASA.

The 95,000 acre Woolsey fire in November 2018 which has coated Southern California with an apocalyptic orange glow may have released radioactive particles and toxic chemicals into the air, after scorching the land on the closed-down government weapons testing facility in Simi Hills known to be contaminated from decades of experiments.

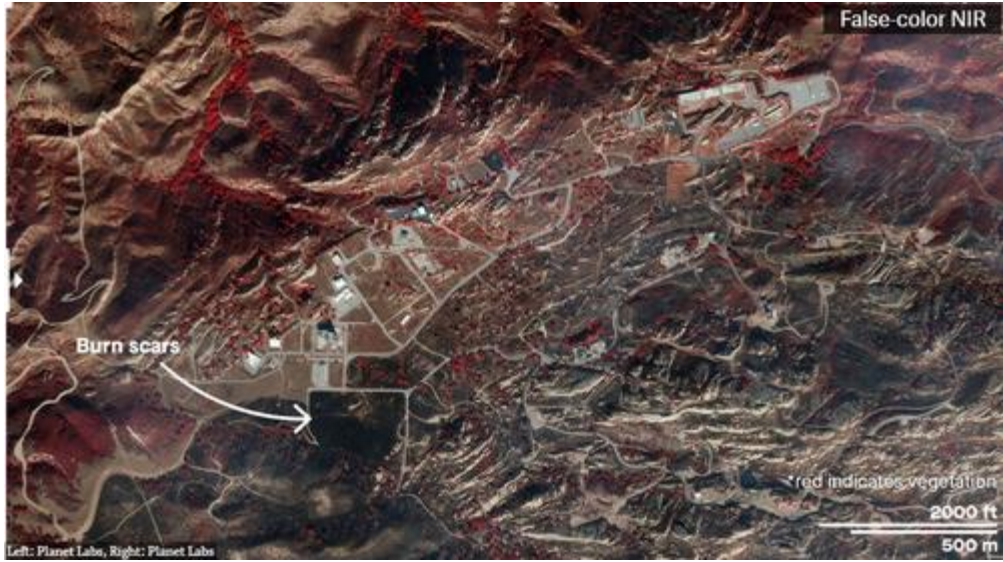
Figure 24. Burn scars from Woolsey fire around Santa Susana field laboratory.

Satellite imagery tells a similarly two-sided story. These images show that the fires did spread to the compound, but they did not take down structures. With near-infrared (NIR) imagery, dense vegetation appears red while burn scars from the Woolsey fire contrast as dark brown. According to a Draft environmental statement from the Energy department, Santa Susana Field Laboratory and its adjoining Northern Buffer Zone has never been fully decontaminated.

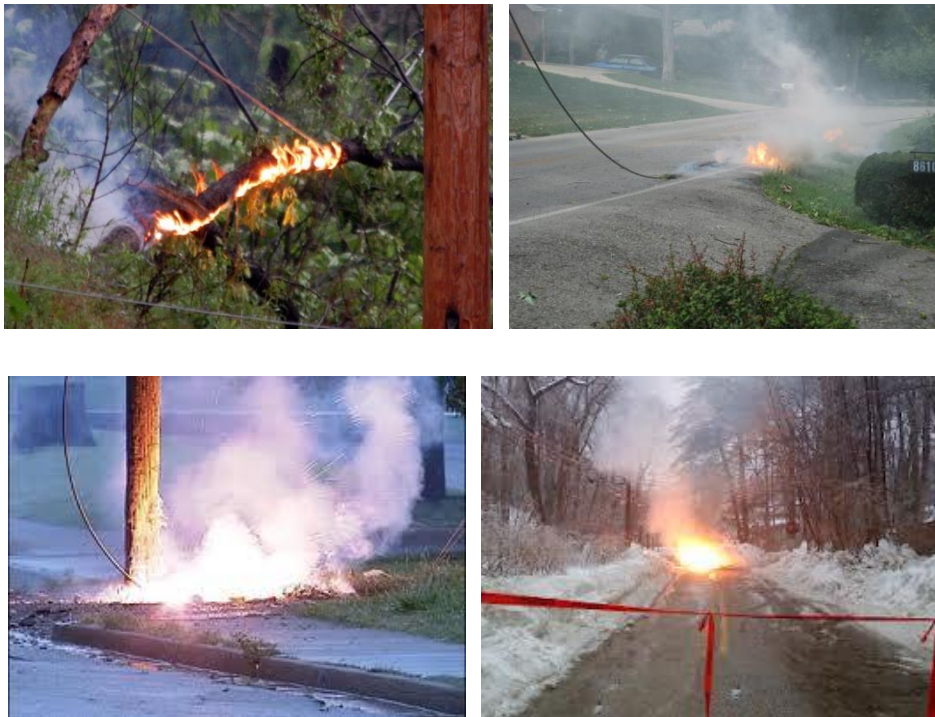
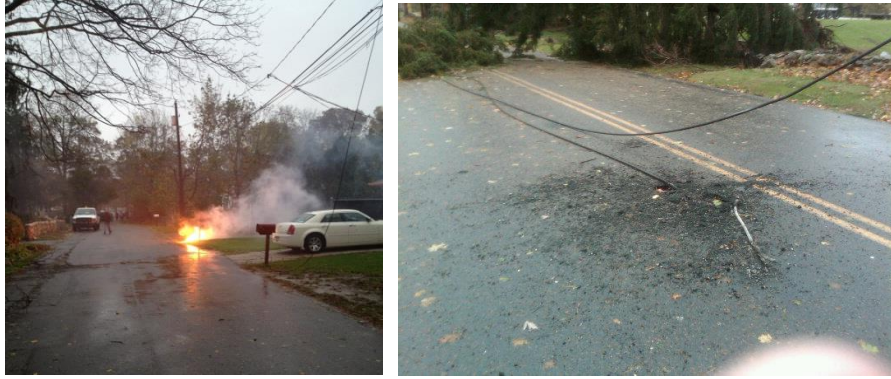
Figure 25. Downed overhead power lines constitute a sparking fire hazard in addition to their electrocution hazard.

Winds would tend to be channeled and strengthened in the Canyon downing the overhead powerlines. One would not think that such winds would take down big high-tension power lines. These could be replaced by insulated wires or placed underground like in European countries in association with HVDC instead of HVAC transmission, at least in sensitive locations.

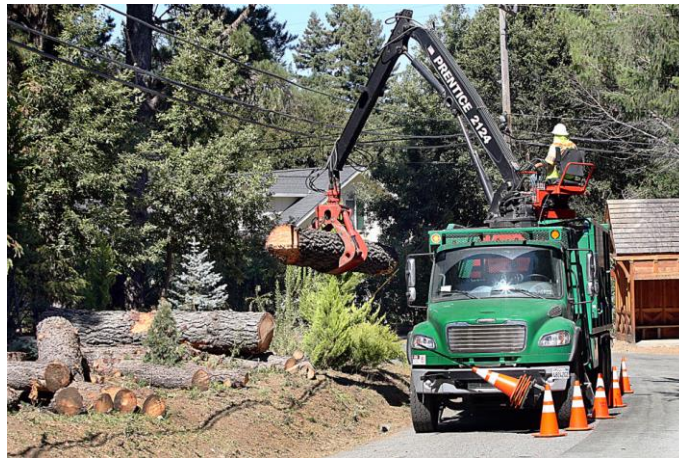
Figure 28. Tree removal around overhead power lines. Santa Cruz, California.

Clearing away vegetation and trees 15 feet back from power lines could lead to the loss of critical habitat, erosion and allow encroachment of invasive species. And shutting off power to remote rural areas is seen as a risk to elderly and infirm residents who may rely on the power for their medical needs. Investigators found the deadly Cascade
