# THREE MILE ISLAND ACCIDENT

© M. Ragheb

## 1. INTRODUCTION

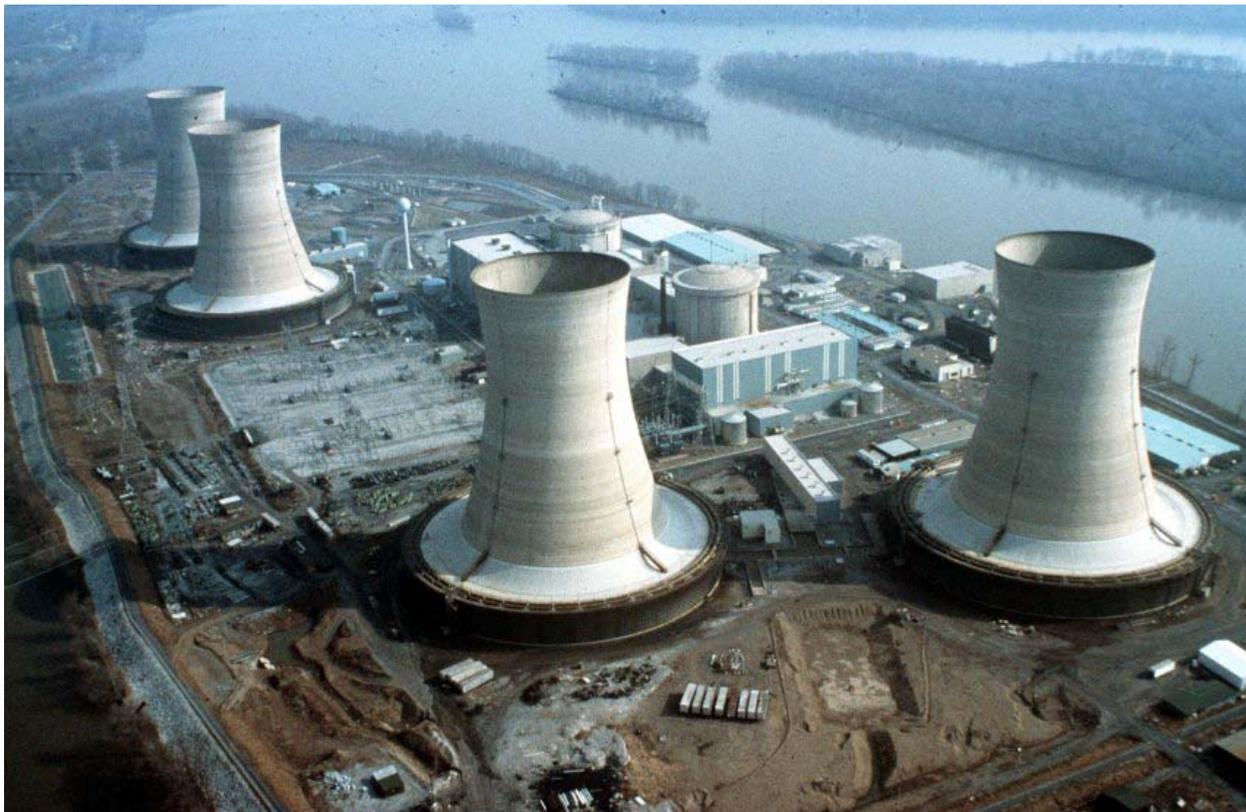
Figure 1. Metropolitan Edison's unit 2 Pressurized Water Reactor (PWR) of 961 MWe of electrical capacity is the capped cylindrical building between its two cooling towers in the foreground. Unit 1 in the back was unaffected by the accident and continued operation.

It occurred in the early hours of the morning at 4:00 a.m. on March 28, 1979, at Unit 2 (Fig.1) of the Metropolitan Edison utility's plant, while it was operating at 97 percent of full power. The plant consisted of two Pressurized Water Reactors (PWRs) each of an electric capacity of 961 MWe.
